## **ANNUAL REPORT FOR 2009**

Stella Bridge Mitigation Site Onslow County TIP No. B-2938

Prepared By:
Natural Environment Unit & Roadside Environmental Unit
North Carolina Department of Transportation
December 2009

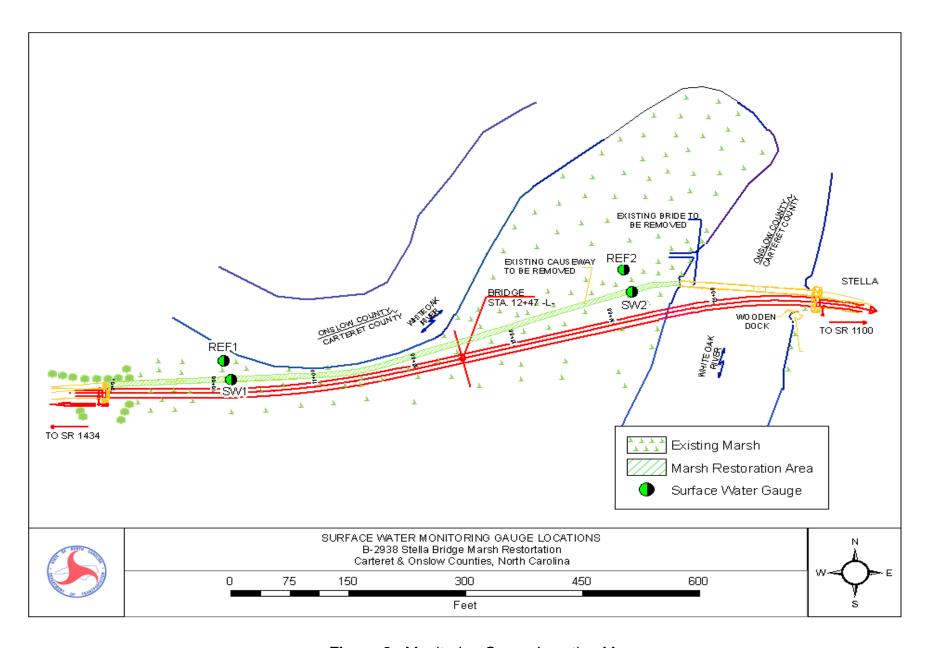
Figure 2. Monitoring Gauge Location Map

The 2009-year represents the fourth year of hydrologic monitoring for the Stella Mitigation Site. Both of the surface water gauges indicated inundation patterns similar to that of reference gauges.

NCDOT proposes to discontinue hydrologic monitoring at the Stella Bridge Mitigation Site.
